Passaic Valley Sewerage Commissioners
Water Pollution Control Facilities

**Evaluation of the Existing Heat Treatment Plant
Supernatant Return (HTPSR) Line**

February 2009

Final Report

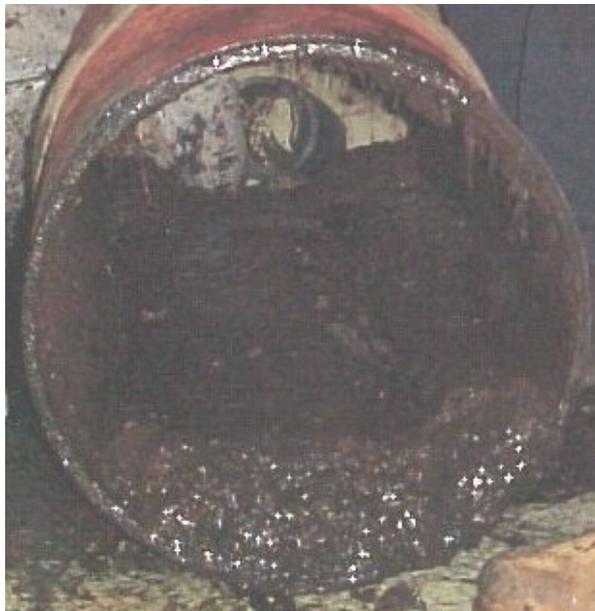
CDM performed and prepared a Hydraulic and Corrosion Evaluation of the HTPSR Line (refer to our February 2003 Report). As part of the corrosion evaluation, the line was inspected externally and internally. During the internal inspection, the HTPSR line was found to have as much as 8-inches of deposited material at the pipe invert, which is reducing the effective capacity of the HTPSR Line. (See Photo 1-1)

Photo 1-1 - View of Deposited Materials within Existing 18" HTPSR Line at EPS.

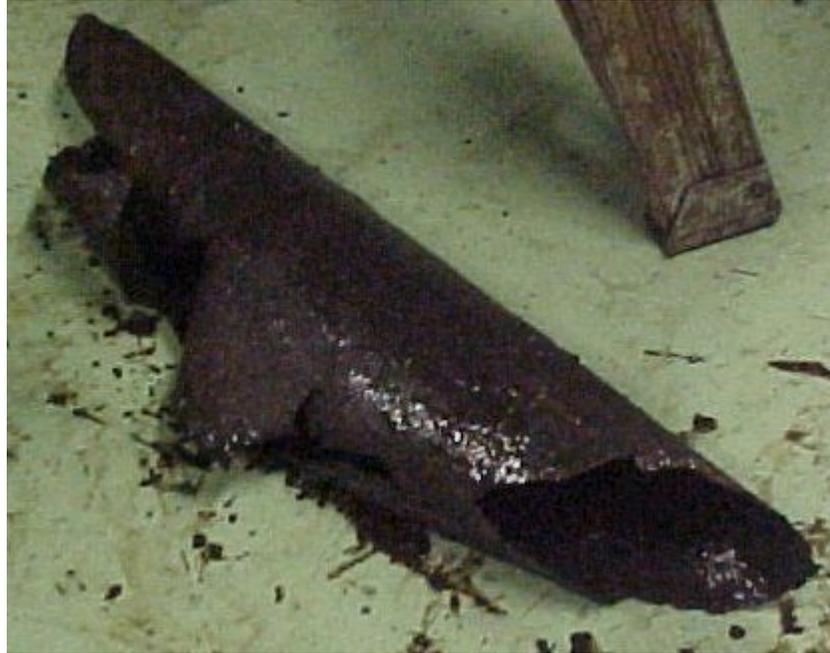
The evaluation also found that the existing liner was delaminating at the ends of each section of pipe due to the minimal corrosion of the exposed ductile iron.

Photos 1-1 and 1-2 depict the deposited materials as well as the “tulipped” liner section.

Photo 1-2 - View of PE Liner Section Removed from Existing 18" HTPSR Line at EPS.

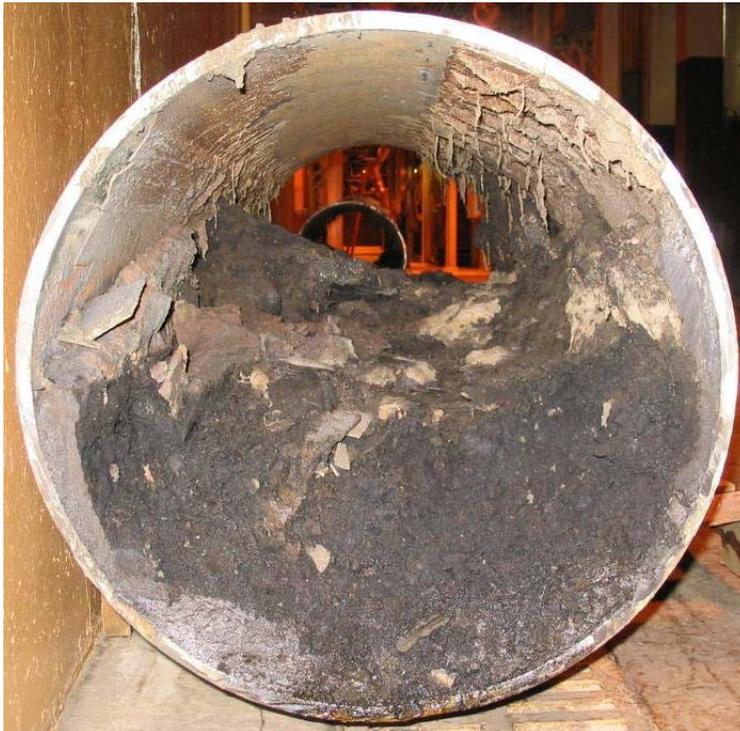
Recently, during the construction of the HTPSR Force Main project under Contract No. A444-B of the existing HTPSR Line were removed to accommodate the installation of the new equipment. Internal inspections of the removed sections of the 20-inch diameter pipeline revealed as much as 14-inches of deposited material at the pipe invert, reducing the effective capacity of the HTPSR Line. (See Photo 1-3)

Left - Photo 1-3 - View of Deposited Materials within Existing 20" HTPSR Line at SDTs.

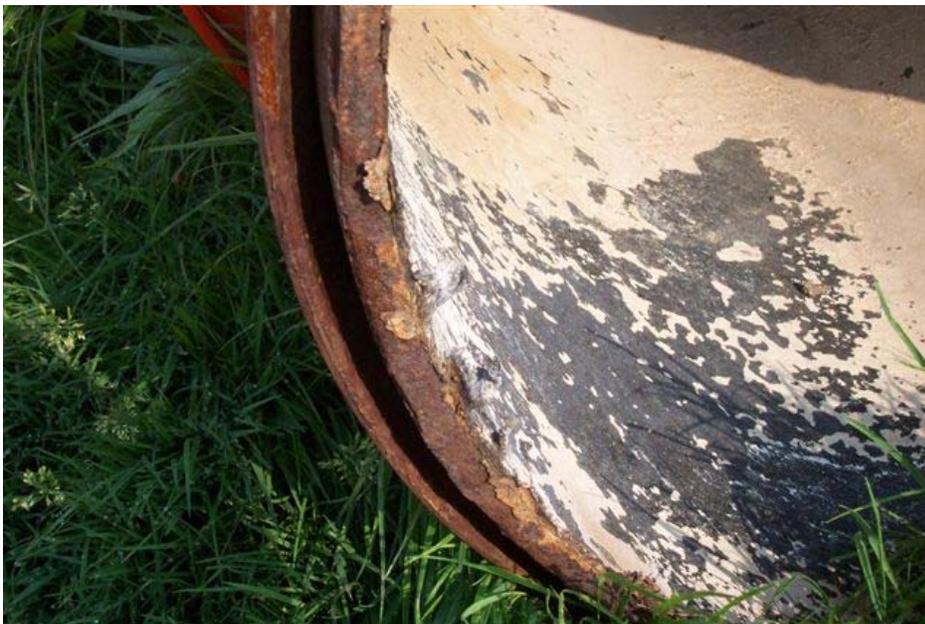
Photo 2-1 - Piece of pipe with the existing polyethylene liner intact (Before)

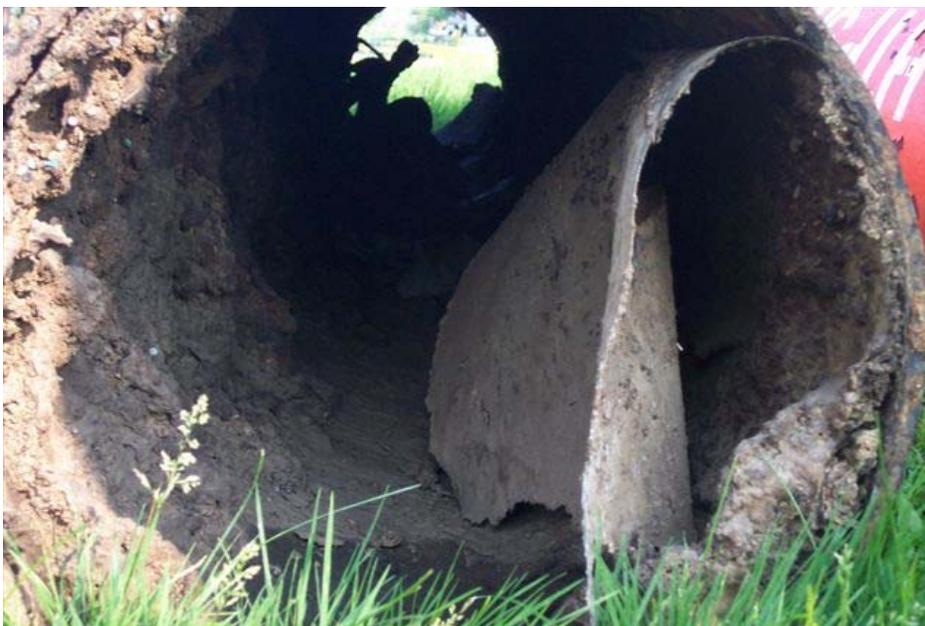
Photo 2-2 - Piece of pipe with the existing liner failing (Before)

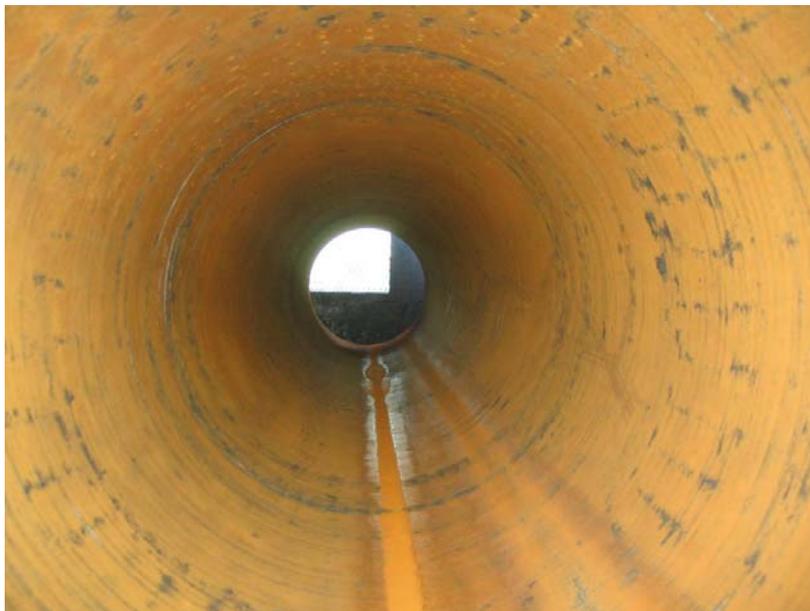
Photo 2-3 - Piece of pipe with the existing polyethylene liner intact (After)

In order to successfully remove the existing polyethylene liner from the interior of the existing HTPSR, BI indicated that they utilized a water pressure of 30,000 psi for the segments of pipe where the existing liner is failing and up to 40,000 psi for the segments of pipe with the existing polyethylene liner intact.

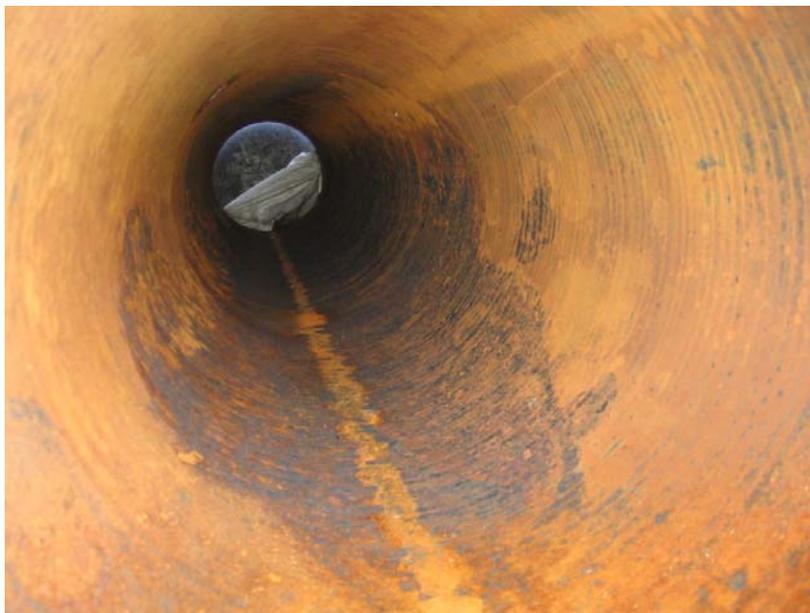
Photo 2-4 - Piece of pipe with the existing liner failing (After)

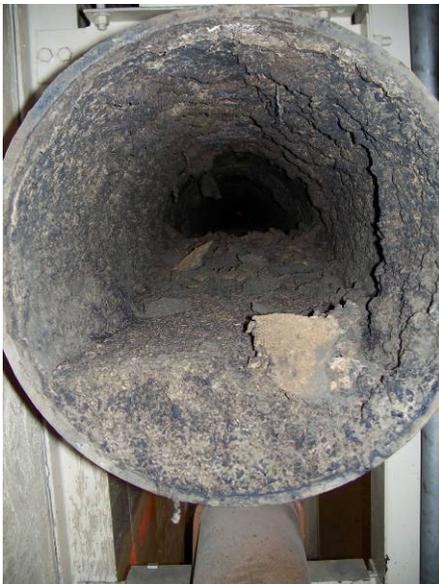
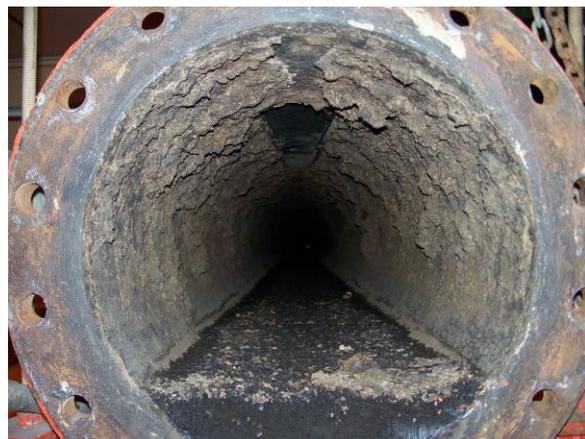
Photographs (above) were taken at both ends of pilot study pipe prior to line cleaning and sludge removal.

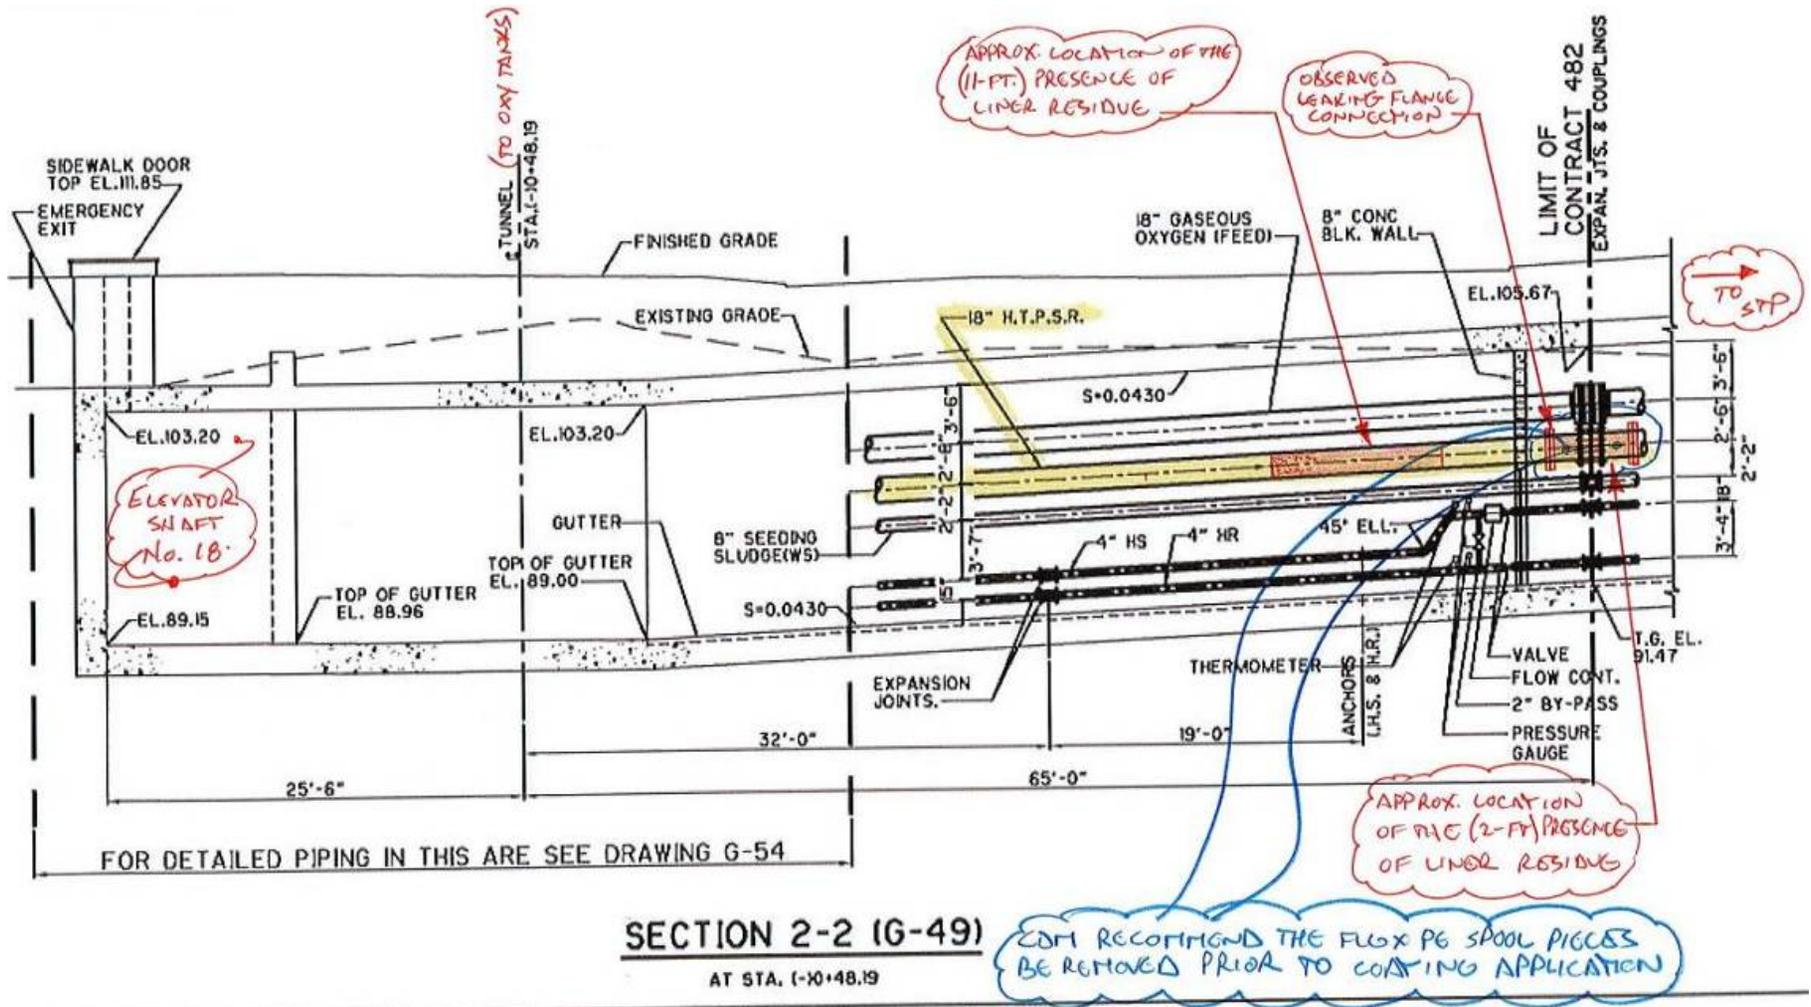
It was also observed during the week that one of the flanged joints was leaking, most likely as a result of the high pressures from the liner removal process.

Refer to the above sketch for the location of the leaking joint.

In November, PVSC's pipe shop reconnected the piping in the vicinity of the flexible coupling location to repair the leaking flanged joint damaged during the liner removal process. Following the mechanical work, PVSC's pipe shop performed a low pressure air test, (not

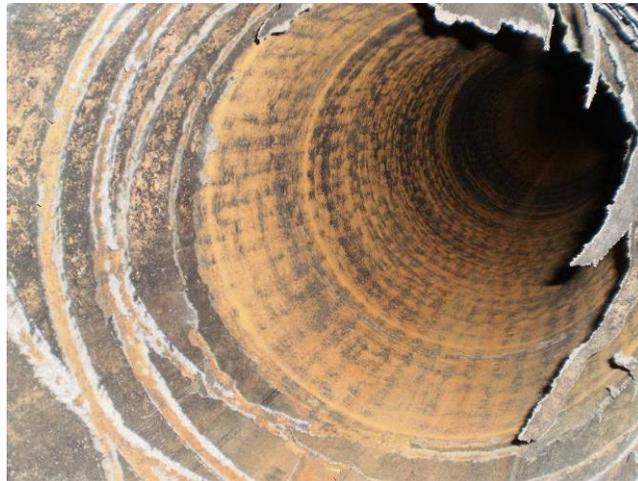
Out of the approximate 150 foot length of pipe that was cleaned, approximately, CDM estimates that approximately 80% of the liner was successfully removed.

The Photograph (above) shows the unsuccessful area in the vicinity of the flexible coupling located at the approximate mid-point of the pilot study area.

In order to keep the pilot study moving forward to the next step (i.e. coating system application/installation), this unsuccessful liner removal location was documented and noted. Broadbent was made aware of the issue so they can evaluate the equipment used in order to come up with a more efficient way to remove the liner at locations similar to this one (i.e. flexible couplings).

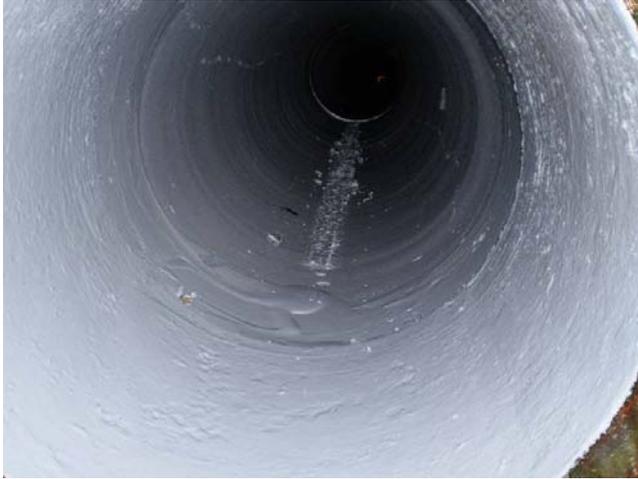
The photograph to the left shows a representative view of the Final Three-Step Sauereisen Vinyl Ester Coating System installed by SP Thomas Coating.

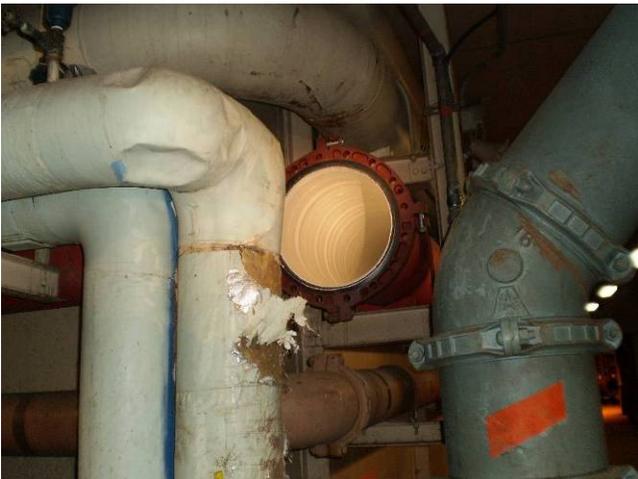
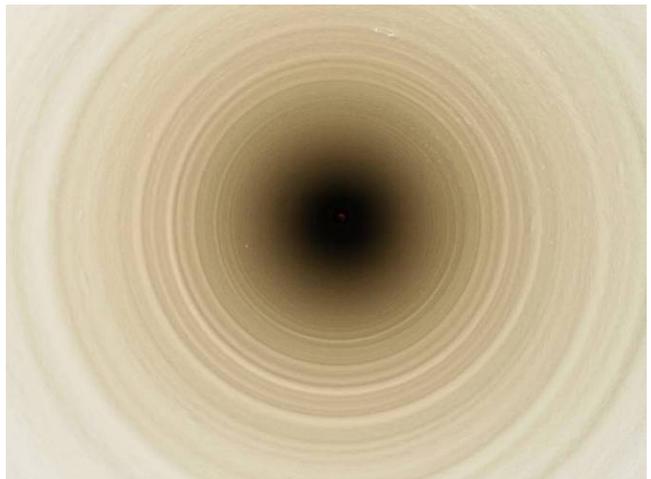
The Photographs (above) show the 1-Step 100-Percent Solids Epoxy Coating System by Warren Environmental and installed by A&W Maintenance.

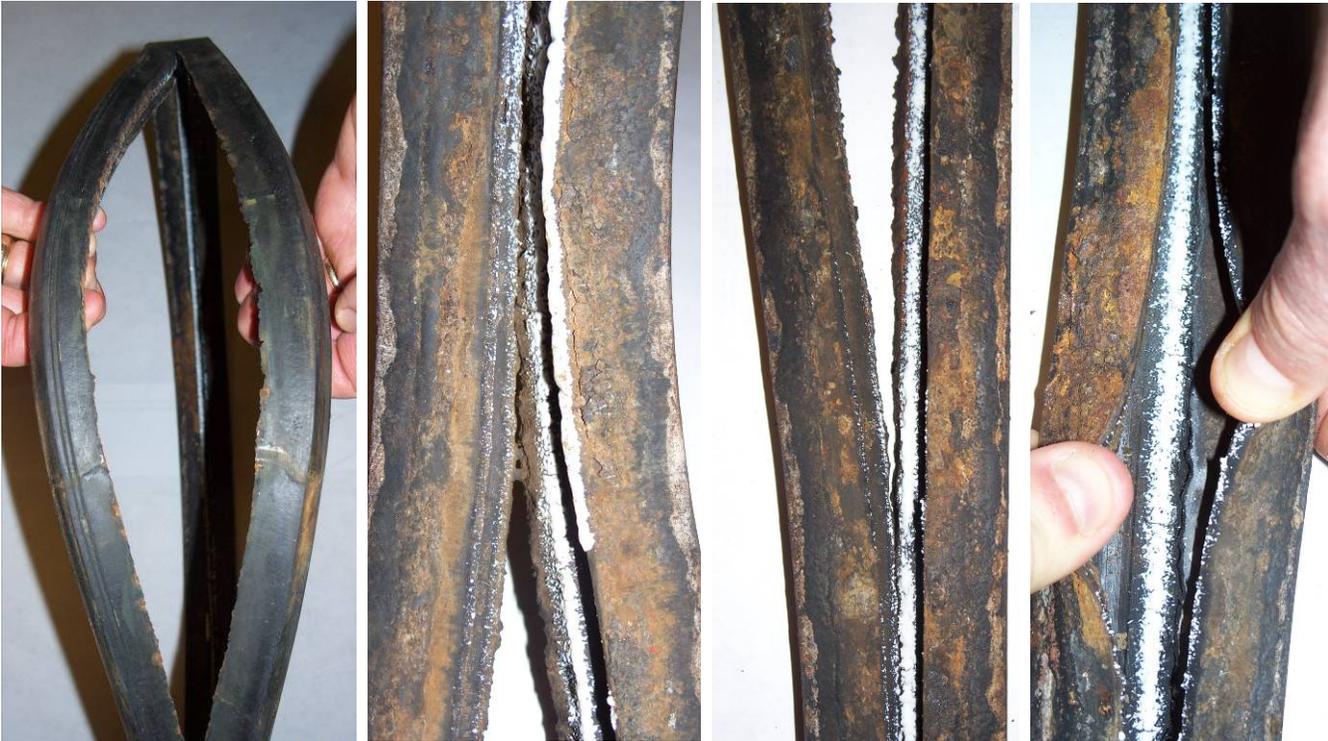
witnessed by a CDM representative.) The results of this air test revealed that a Victaulic coupling gasket had been damaged as a result of the high water pressure liner removal process.

The Four Photographs (above) show the damage to the Victaulic coupling gasket.

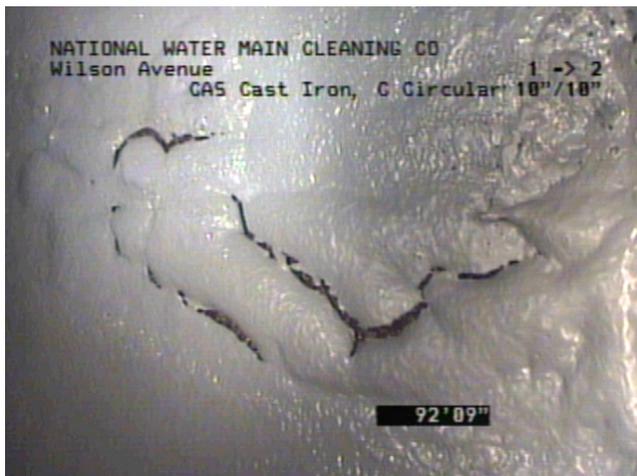
[Note and observation – The 3-step Sauereisen vinyl ester coating system appeared to accumulate within the invert of the pipe and flake between primer and top coats. Cure times under ambient conditions between coats was much longer than product data indicated which would cause for longer /additional days to the project/pilot duration]

The photograph to the left shows the disruption between the coating system layers.

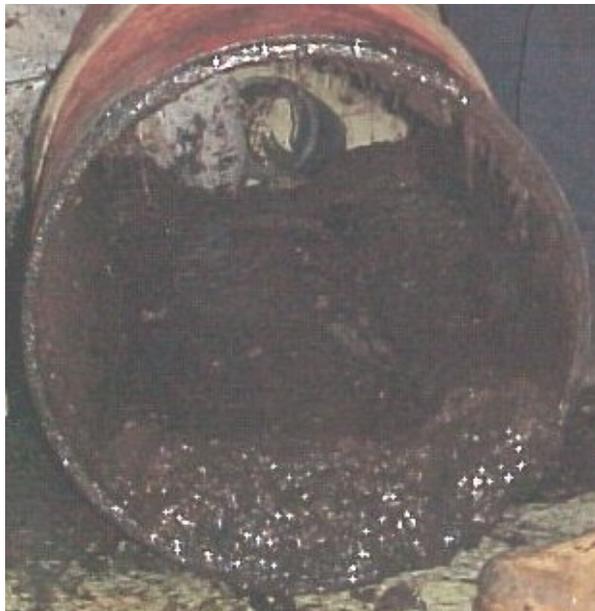
The evaluation also found that the existing liner was delaminating at the ends of each section of pipe due to the minimal corrosion of the exposed ductile iron.

Photo 1-1 - View of Deposited Materials within Existing 18" HTPSR Line at EPS.

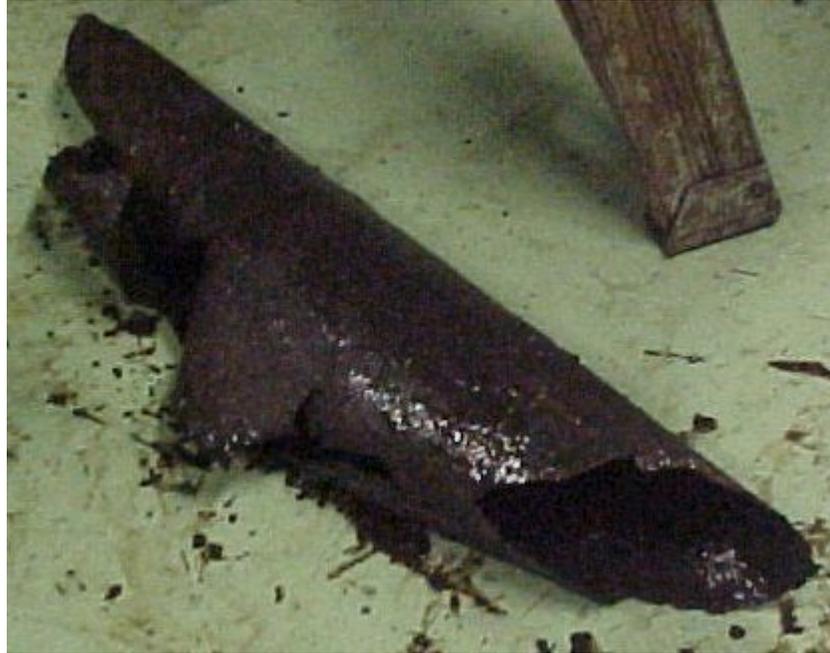
Photos 1-1 and 1-2 depict the deposited materials as well as the “tulipped” liner section.

Photo 1-2 - View of PE Liner Section Removed from Existing 18" HTPSR Line at EPS.

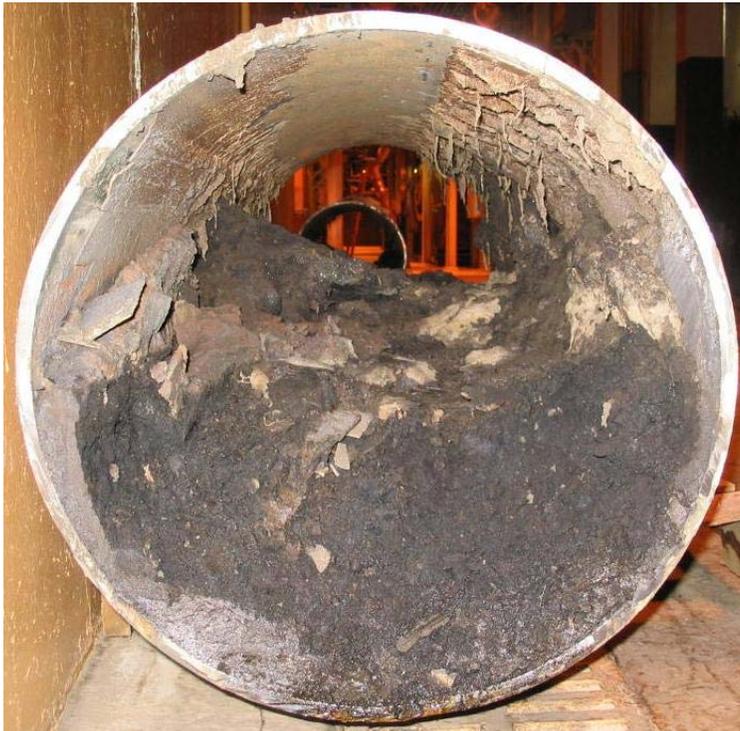
Recently, during the construction of the HTPSR Force Main project under Contract No. A444-B of the existing HTPSR Line were removed to accommodate the installation of the new equipment. Internal inspections of the removed sections of the 20-inch diameter pipeline revealed as much as 14-inches of deposited material at the pipe invert, reducing the effective capacity of the HTPSR Line. (See Photo 1-3)

Left - Photo 1-3 - View of Deposited Materials within Existing 20" HTPSR Line at SDTs.

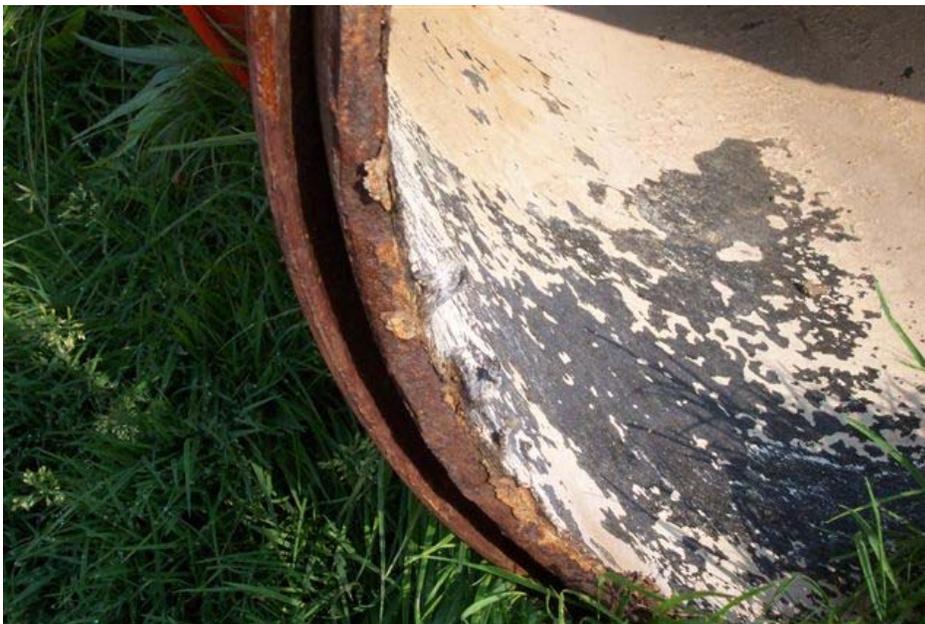
Photo 2-1 - Piece of pipe with the existing polyethylene liner intact (Before)

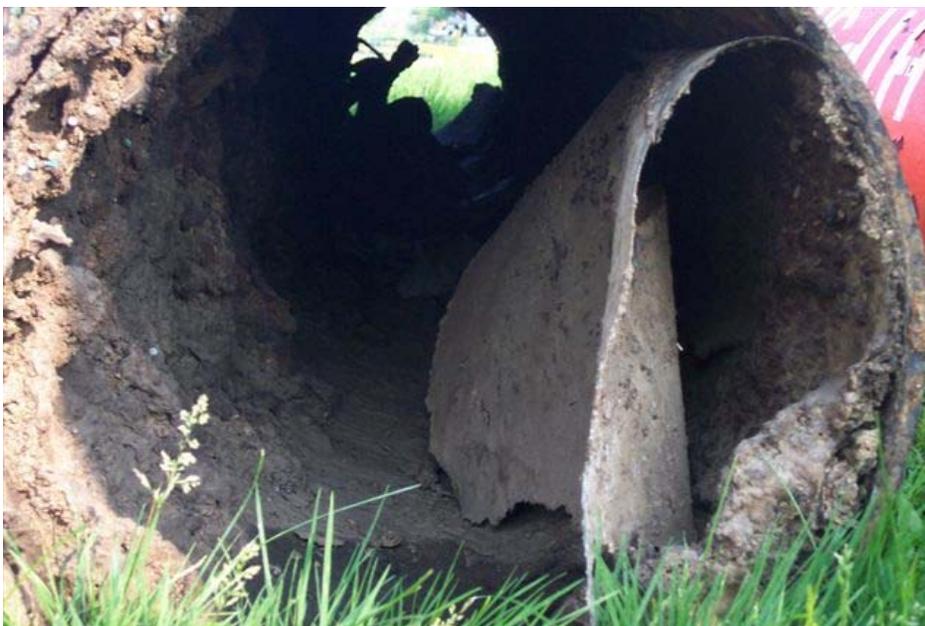
Photo 2-2 - Piece of pipe with the existing liner failing (Before)

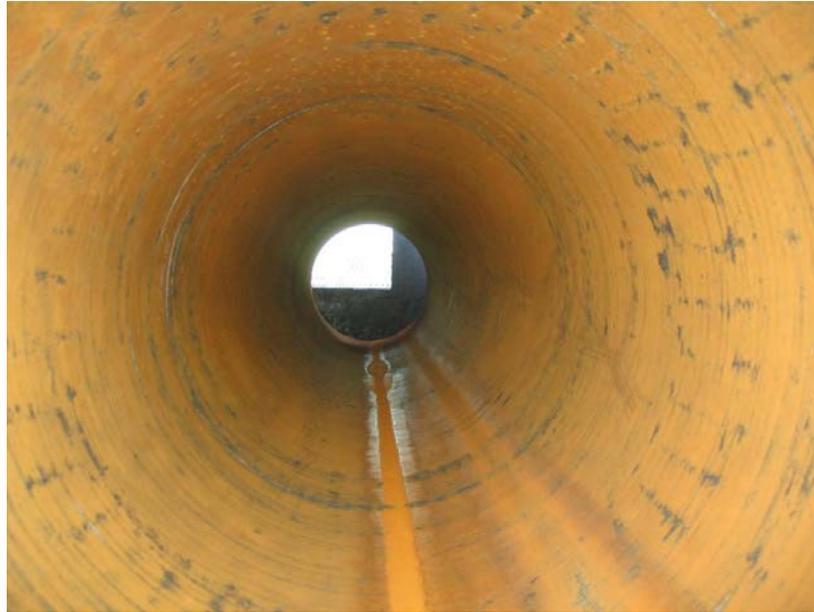
Photo 2-3 - Piece of pipe with the existing polyethylene liner intact (After)

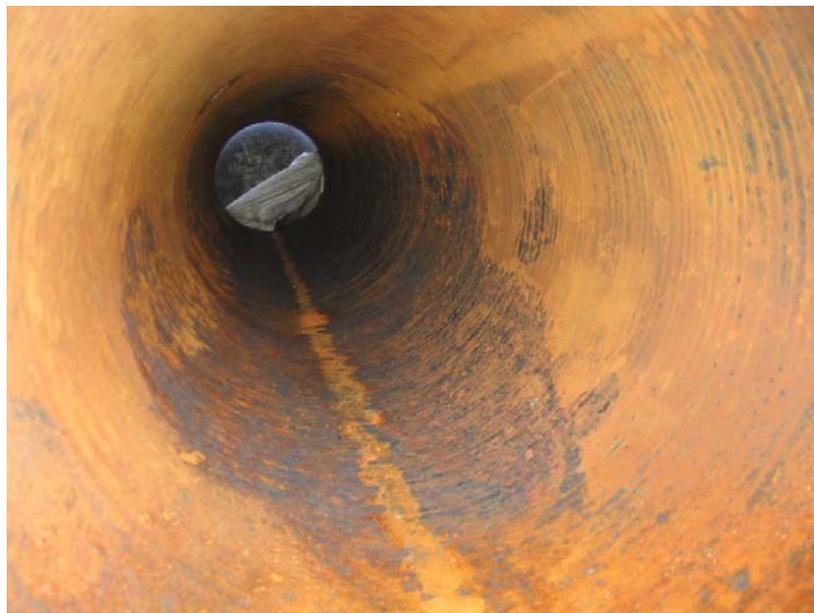
Photo 2-4 - Piece of pipe with the existing liner failing (After)
